Title: What REALLY Happened at WIPP? The Tale of Two Fires

What REALLY Happened at WIPP?

The Tale of Two Fires

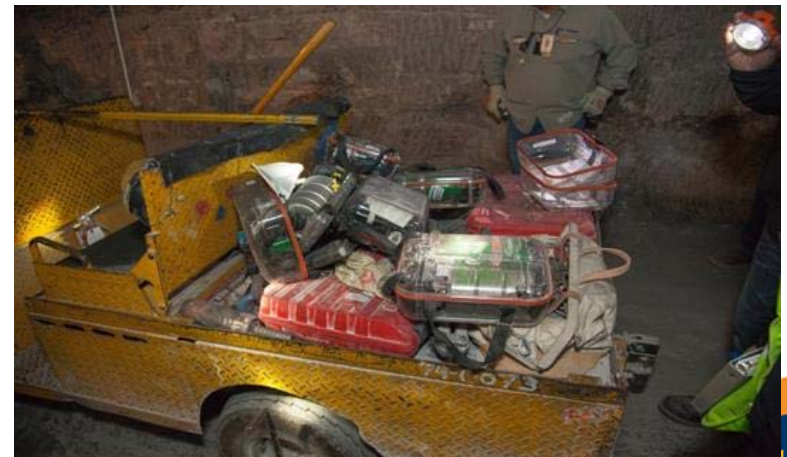
Inset Shows Obstructed Reflectors

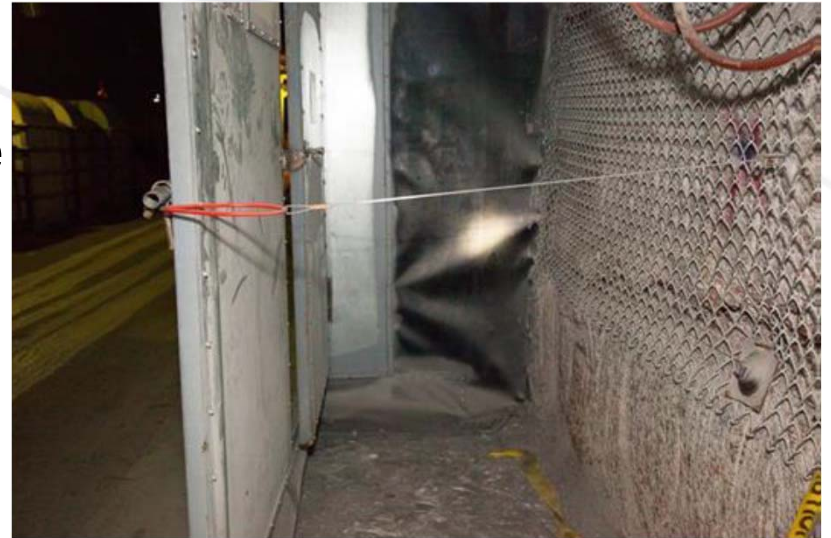
Air Lock Doors Wired Open

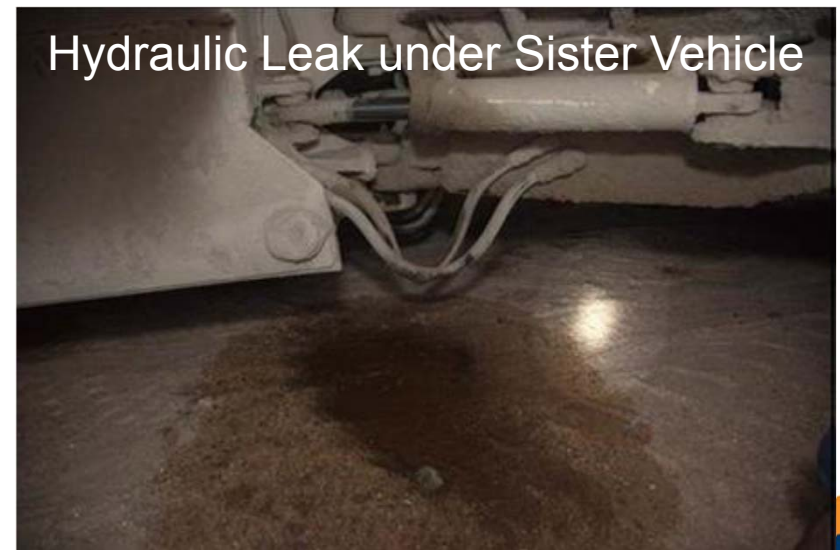
Hydraulic Leak under Sister Vehicle

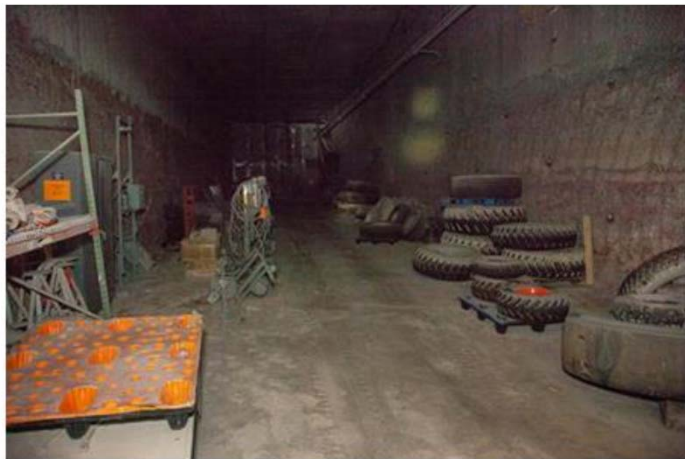
Combustible Loading in the Mine

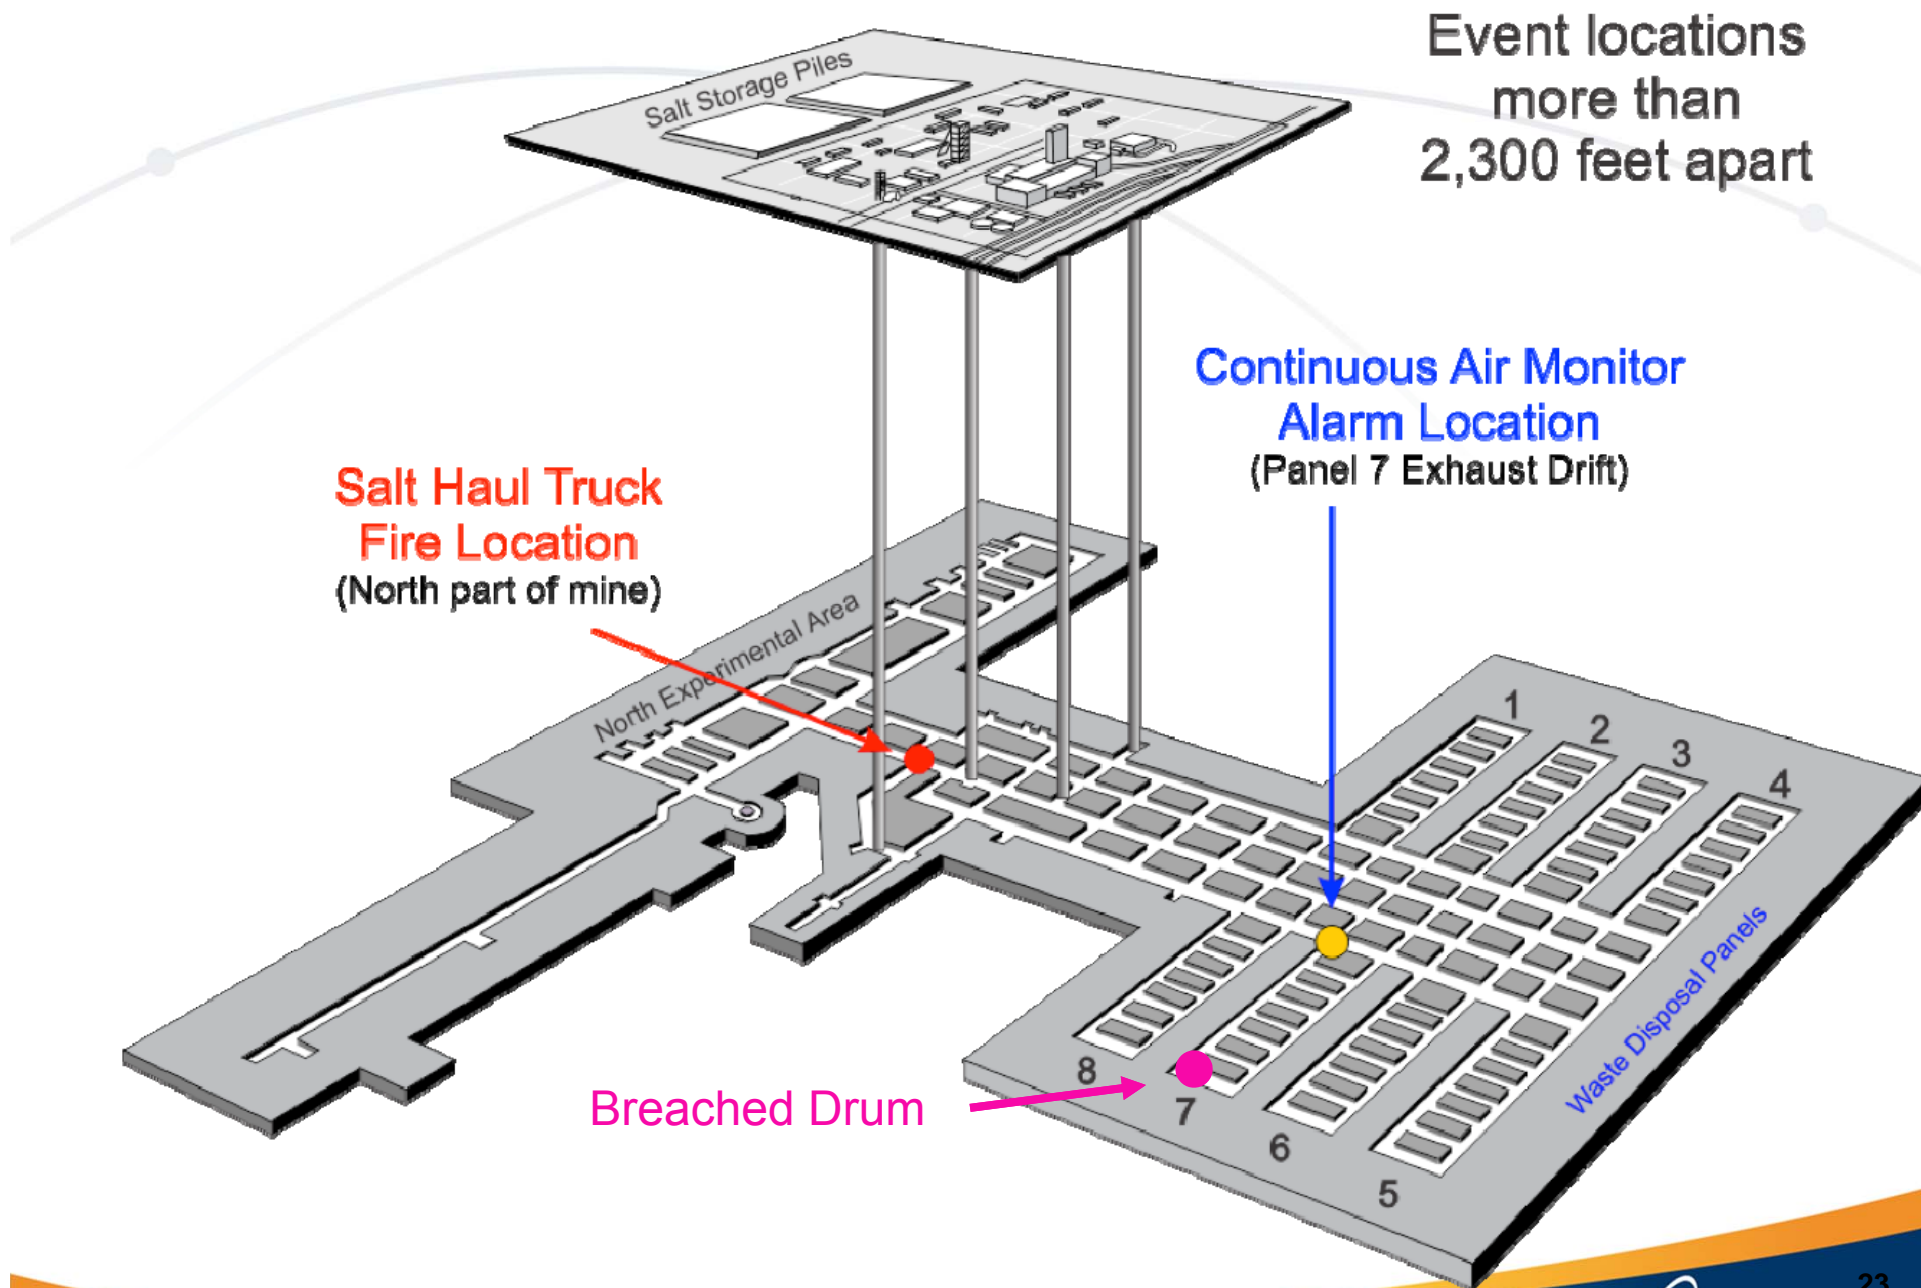
WASTE DISPOSAL PANELS

Salt Truck Fire 2/5/14

24 rows of CH waste in Room 7 of Panel 7

CAM Alarm Location (Panel 7 Exhaust Drift)

- Panels 1-5 filled and sealed
- Panel 6 filled and sealing in process
- CH waste emplacement in Room 7
- RH waste emplacement in Room 6
- Active mining Panel 8

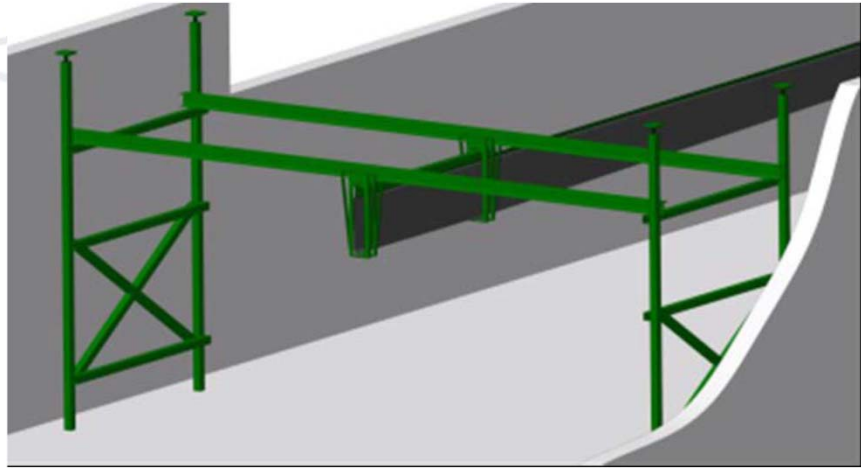
Project Reach

- 90-foot composite boom equipped with high resolution video equipment to take video, photographs and obtain samples
- January 26, 2015
- Cost/benefits?

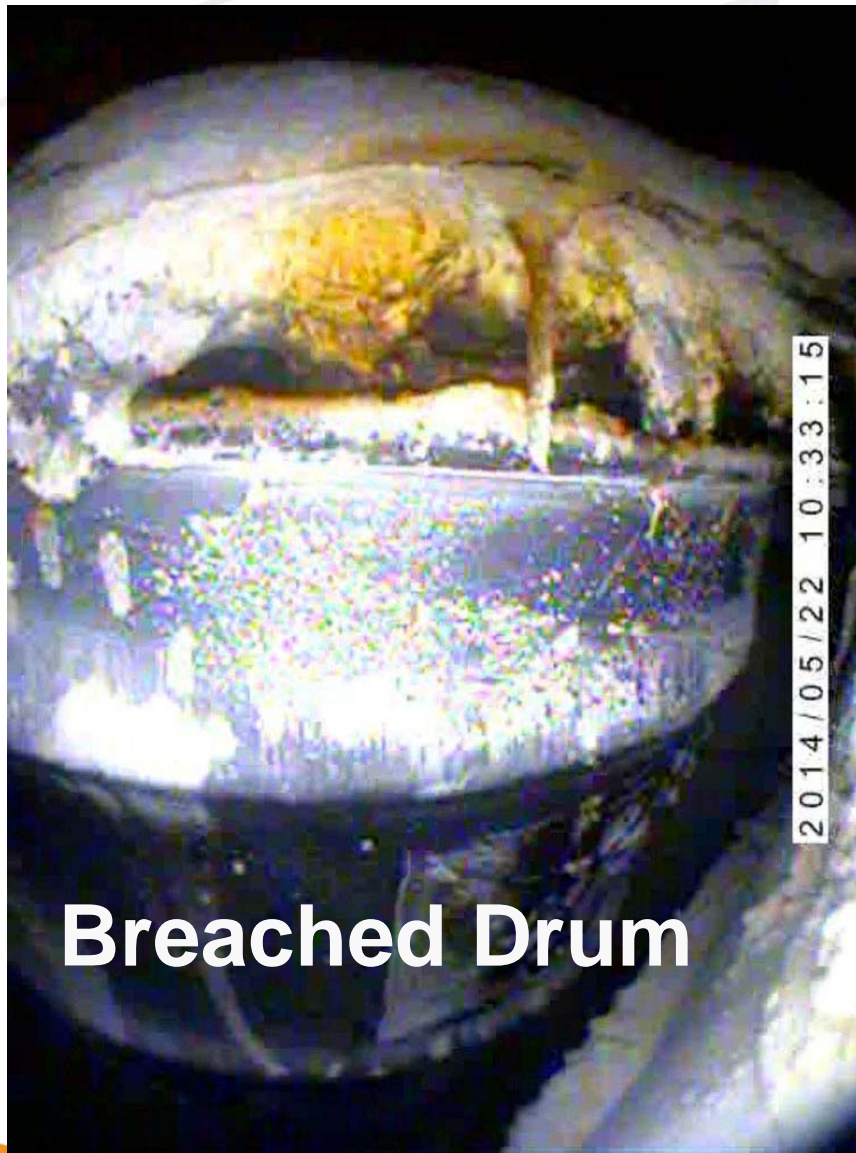
Breached Drum 68660

- Photographic evidence confirmed that a LANL container (drum 68660) was breached.

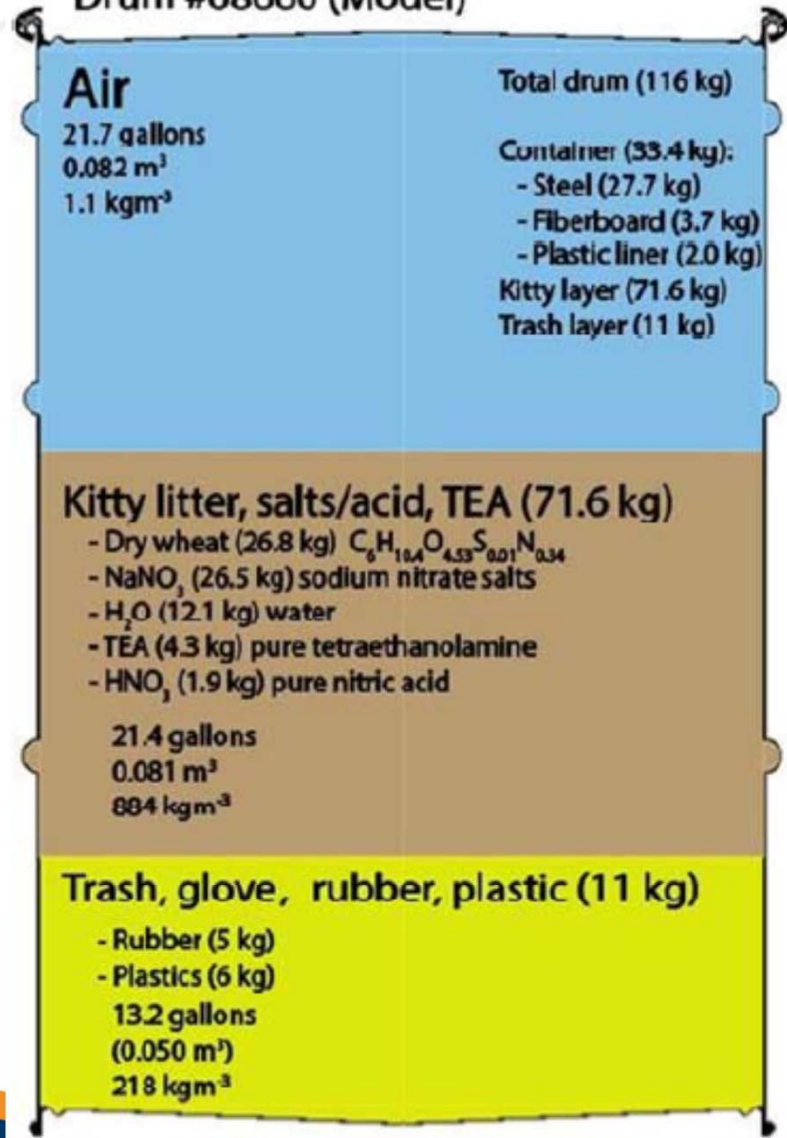
Drum #68660 (Model)

Model and X-Rays of Drum #68660
